Case History for Indoor Storage at Valve Manufacturer

HT 365 Preservation Coating

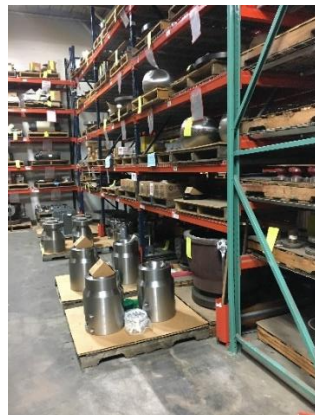
The valve manufacturer has found that the time spent to protect the steel by dipping each piece into the vat to coat with **HT 365** was a time and cost saver as the need to remove rust when needing to assemble a valve can be inefficient and add another expense to the cost of goods sold. The below pieces have thus far been rust free for over 15 months and expected to remain that way for a while. Should additional protection be needed, the manufacturer can simply dip the parts again for another long period of protection. Below is an example of the 15 months of protection provided by **HT 365**. Coated **November, 2015**; still protected as of **February, 2017**.

Next to the rust free parts on the pallet are valve bodies that were not protected and are completely rusted. Unfortunately, they will have to be blasted before assembly.

The parts are dipped and allowed to fully coat all exposed surfaces, then raised and allowed to drip dry. After five minutes, the film is cured and the part is ready to go into storage on the shelf. The customer began dipping parts in November, 2015 and fifteen (15) months later, they are still receiving full protection and are rust free.
