Case History for Indoor Storage at Metals Reclaimer

HT 365 Preservation Coating

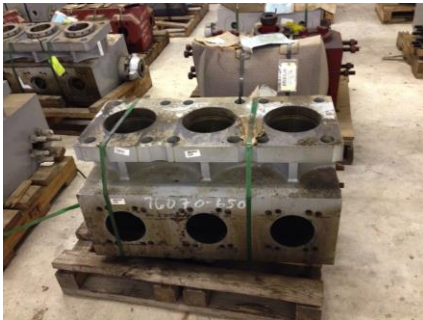
- Customer reclaims scrap metal and in 2015 purchased these frac blocks and other metal equipment as “scrap” from the local facility of a Houston-based, major oilfield equipment manufacturer and supplier.

- This equipment was originally intended to be used in South Texas for fracturing-style of horizontal drilling.
- Unfortunately, the drop in oil prices caused this equipment to become expendable.
- Customer purchased the parts as scrap and decided to preserve their condition, recertify them and eventually sell the parts when the market rebounds.
- The parts were originally very expensive and if well maintained provide a healthy profit to Customer in the future.

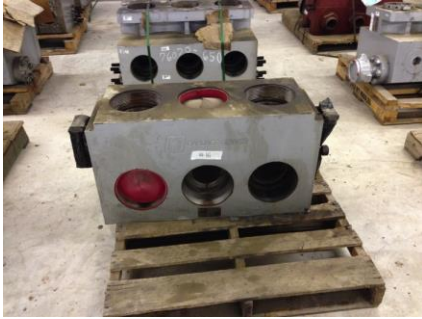
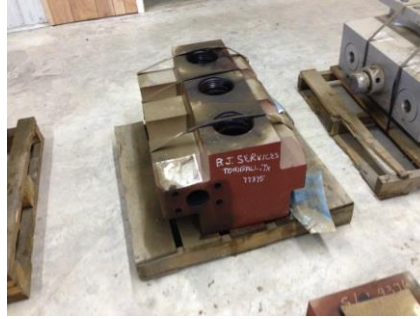
- **The problem:** rust forming on equipment can render it unusable and destroy value.
- Machine finished, steel “frac” blocks were being stored outside in an unpainted state. With exposure to rain, UV and temperature, unprotected steel begins to develop rust bloom.
- This rust was occurring both on the body of the block and on threaded areas.
- Corrosion is especially detrimental to the threaded areas in the block, potentially rendering the block unusable because of the minimal tolerance of the threads to physical surface change that rust can cause.

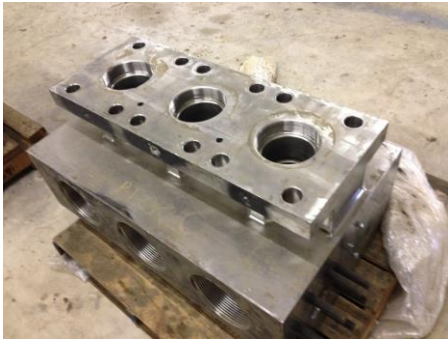
Result: After nine months, all surfaces coated with **HT 365** were rust-free, especially in the threaded areas. This result preserves the functionality of the block and value for eventual resale.

- Customer spray applied film of **HT 365**
- **HT 365** was applied with a pump-style garden sprayer at a .4-.5 mil dft on the body of the block with particular attention to threaded areas.

- The blocks were stored in a warehouse where the temperature and humidity is not controlled.
- No further maintenance required
- Date of application: March 2015
Date of observation: May 29, 2015
- Customer shared 6 months later that **HT 365** continued to protect the steel.
